DOI: 10.21005/pif.2019.37.B-01

PROBLEMS OF MAINTENANCE OF SACRAL BUILDINGS ON AN EXAMPLE IN SMALL CITIES AND VILLAGES OF WESTERN PODILLYA

ABSTRACT

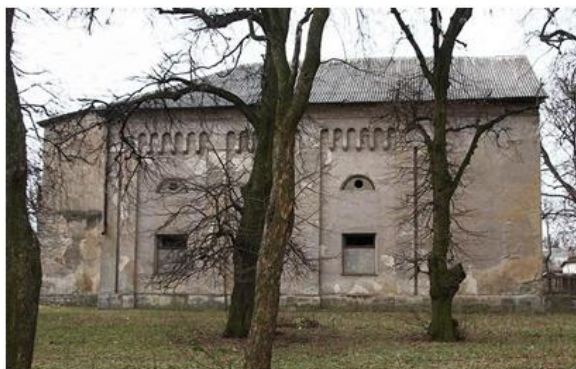
A large number of temples in need of restoration and renewal are found in the Borshchiv district of the Ternopil region. (Figure 1). Among them - in the settlement Melnitsa-Podilsk is situated a modest, devoid of tower, the church of St. Henry, built in 1861. To the south of Borshchiv, among the picturesque hills covered with forests, the village of Visichka

1 - church of St. Henryk in Melnitsa-Podilsky; 2 – St.Nicholas church in Vysichka village; 3 – Catholic church in Vysichka village; 4 - Catholic church in Dzvunyachka village; 5 - the Catholic church in Zalissya village; 6 - the Catholic church in Kruvche village; 7 - the Catholic church in Strilkivtsi village; 8 - the Catholic church in Turilche village (1871 p.); 9 - Church of John the Theologian in the village of Ivan-Puste.

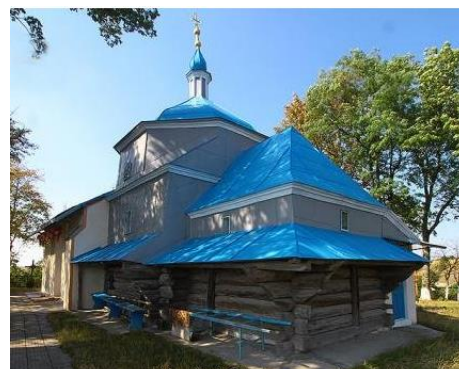
2

is situated. In the village have at once two monuments, which are distorted by time and people - the wooden church of St. Nicholas and a semi-ruined Catholic church. St. Nicholas Church (1763) is a characteristic work of the Podillya school of folk architecture, it belongs to the monuments of national significance and, as if, protected by the state (guard. № 648/1) [9, 10].

However, today, it lost it's authentic appearance through the built stone bubenice instead of the original wooden; above the fear of the church was clogged with a metal "sarcophagus", under which the wood is further spoiled. Near the wooden church there is a dilapidated, semi-ruined Catholic church.

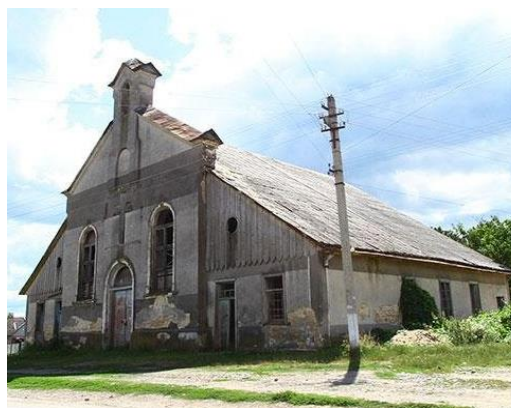
4

In the village Dzvunyachka Borshchivsky district, along with a well-ordered Greek Catholic masonry Trinity Church (1889), there is the Church of the Mother of God of Angels (1894), heavily damaged during the Second World War. In Soviet times it was used as a warehouse, milk receiving point, cafe "Romashka", and with the achievement of Ukraine's independence, the church was used as a sports hall. Today, the building with strange completions is empty, continues to collapse and requires restoration. The same fate happened with the Catholic church in Zalissy, in which there was a warehouse in the Soviet years, and the castle church of the Immaculate Conception of the Virgin Mary in the village of Kryvche (1650). The churches in the villages Strilkivtsi and Turilche are also almost ruined [8].

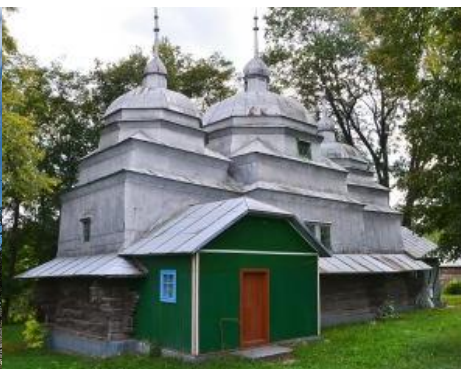
9

The monument to the Podolsk School of Folk Architecture, protected by the state (guardian number 1566/1), is the wooden church of John the Theologian, located in the village of Ivan-Puste [2]. Today, only the first tier of walls remained in the wooden, above - the building was covered with a tin, made completion to the altar part. As you can see, the security number did not prevent the peasants from distorting the building by inefficient repairs.

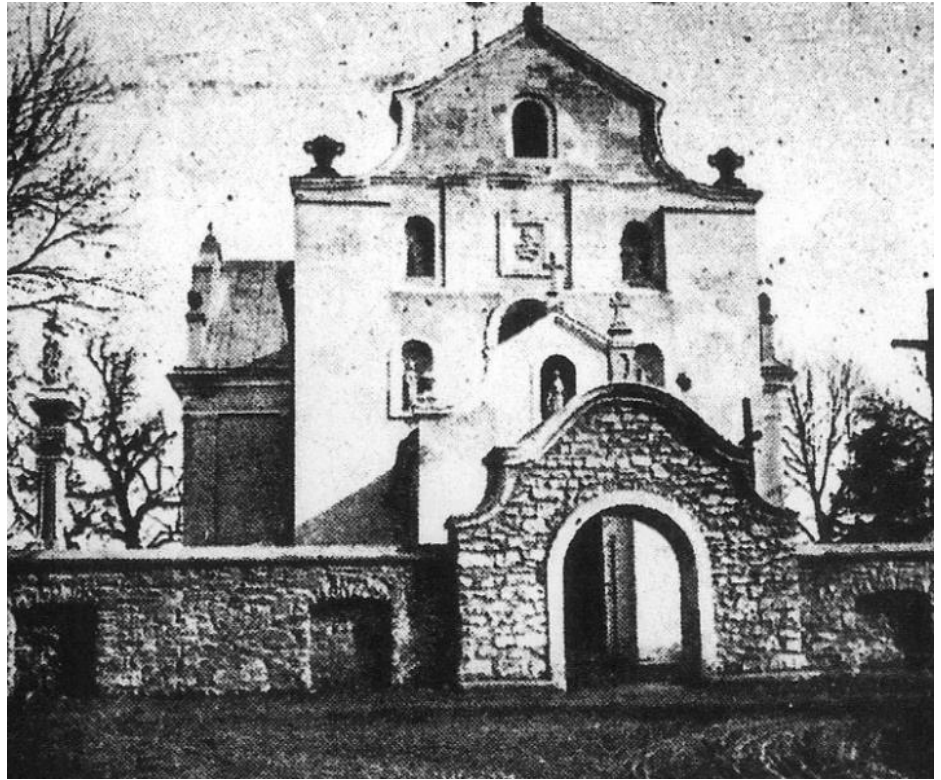
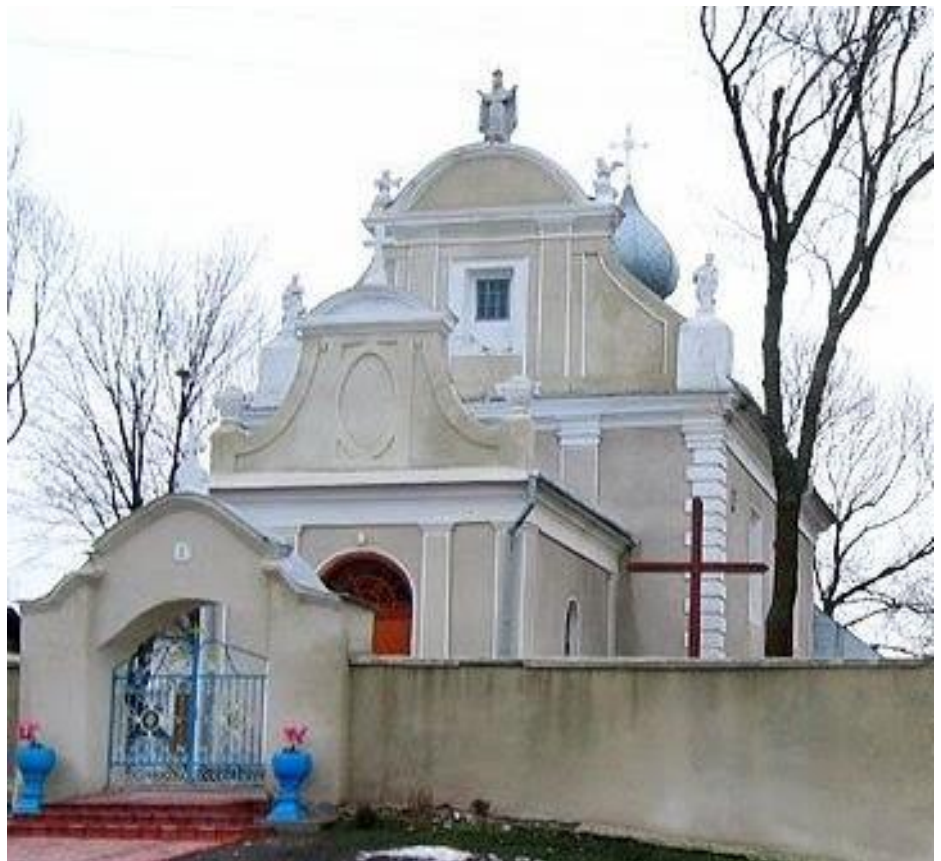
Fig.2. Church of the Protection of the Virgin Mary in the village of Grimayil: 1 - the old image of the Trinitarian church (photo by Y. Ung [5]); 2 - the current state of the Pokrovsky church (photo by A. Bondarenko [10]).

Analyzing the state of preservation of the temples in the Gussyatinsky district, we find information about the destroyed in the 1970s Baroque church of trinitarians of the XVIII century in the ancient village of Grimailiv (Figure.2). However, some researchers believe that the church is not destroyed, but strongly rebuilt to the existing Church of the Protection of the Blessed Virgin Mary (1806) [10].

Comparing the old and the present figures one can assume that this is one and the same building with a figured pediment and decorative baroque elements on the facade, but more evidence is needed to confirm this fact [3].
